# 6 MAINTENANCE AND PRESERVATION OF CONCRETE STRUCTURES.

Report 2

## REPAIR OF EROSION-DAMAGED STRUCTURES,

11 April 1980

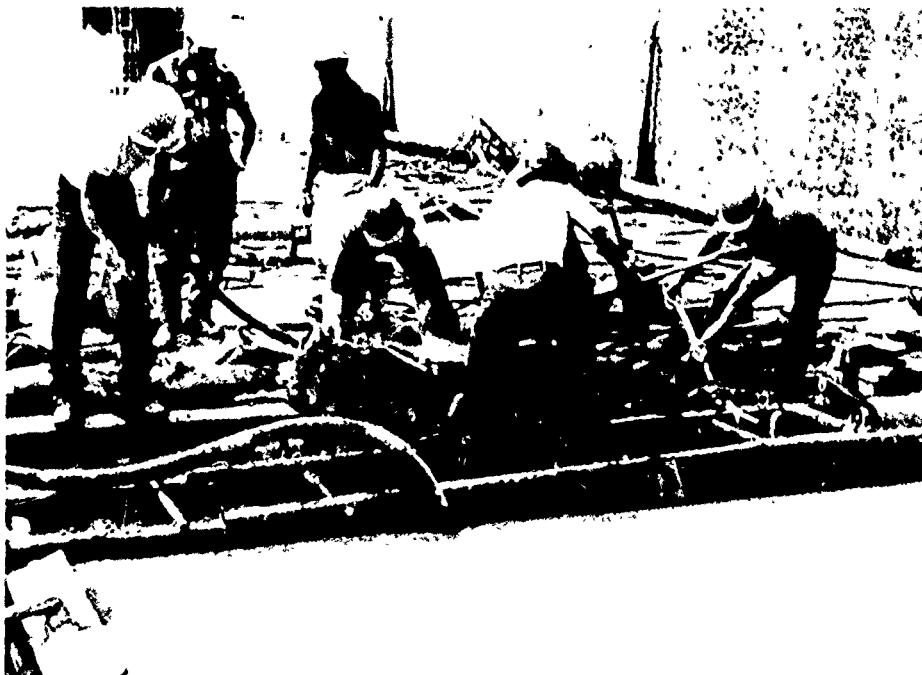
Figure 145. Fiber concrete placement, Kinzua Dam

257. A high modulus epoxy bonding compound was placed on the stilling basin floor immediately prior to placement of the fibrous concrete overlay. The overlay was placed in slab sections (Figure 145) conforming to the original slabs. Slab placement was in alternate sections starting at the upstream end of the row adjacent to the left training wall (Figure 146) and proceeding in adjoining rows to the center of the stilling basin. Relief drains were extended through the overlay (Figure 144). Approximately 1400 cu yd of fiber concrete was required for the overlay, which was placed to el 1180.0, 1 ft higher than the original stilling basin floor from the toe of the dam to a point just short of the downstream end of the baffle piers.

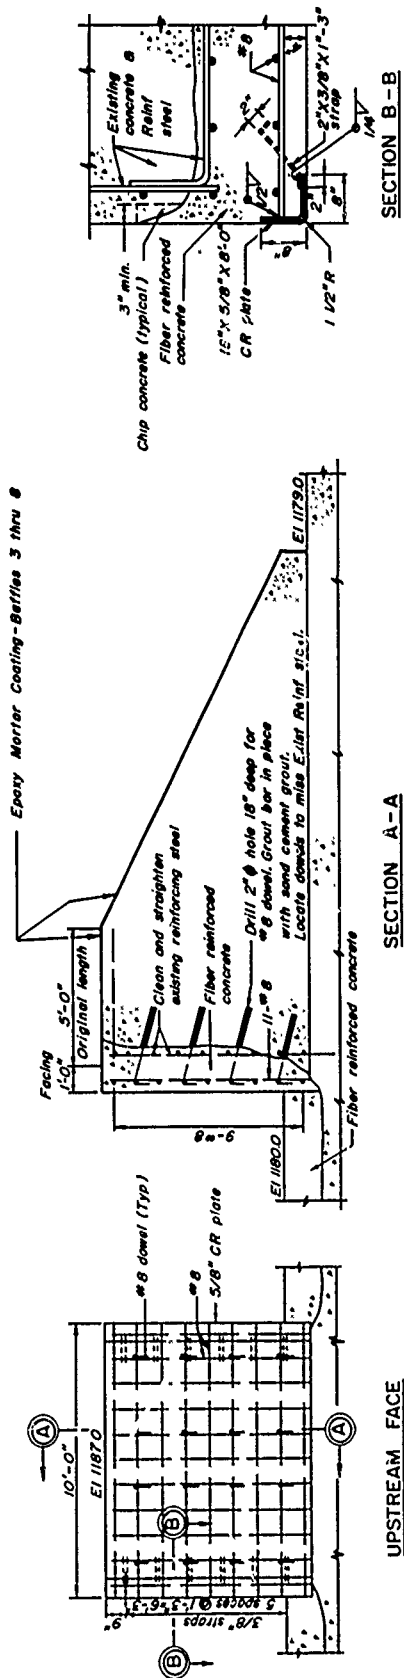
Figure 147. Baffle repair details, Kinzua Dam

258. The baffles were prepared for repair (Figures 147 and 148) in the same manner as the stilling basin slab. Dowels were installed and an epoxy bonding compound applied. The front of the baffles was resurfaced with fibrous concrete and reinforced with No. 8 steel bars. In addition, corner pieces of corrosion-resistant steel plate, 5/8 in. thick, were installed at the upstream corners of the baffles. Both sides, the top, and the back of damaged baffles were coated with an epoxy mortar. This same mortar, a 1 to 1 ratio of epoxy and silica sand, was used to coat the damaged spillway surface to a 1/2-in. average thickness.

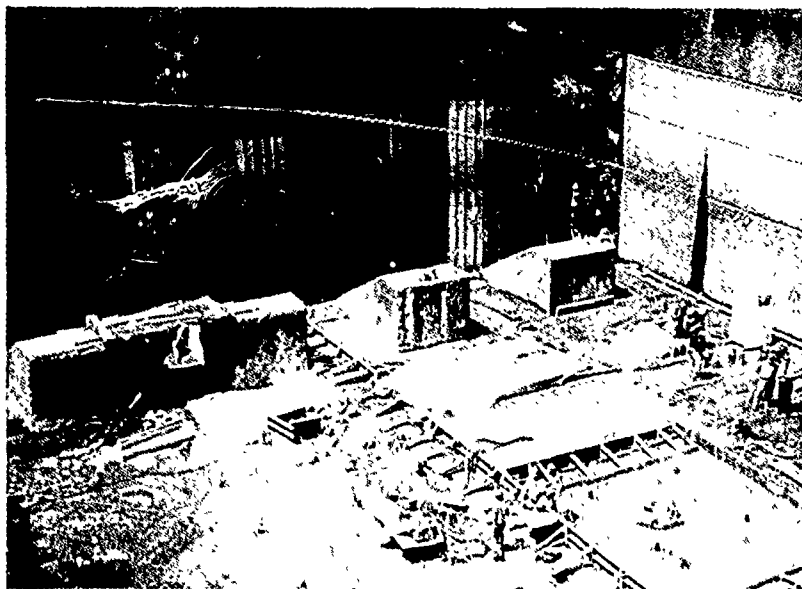
Figure 148. Baffle and basin slab repair,  
Kinzua Dam

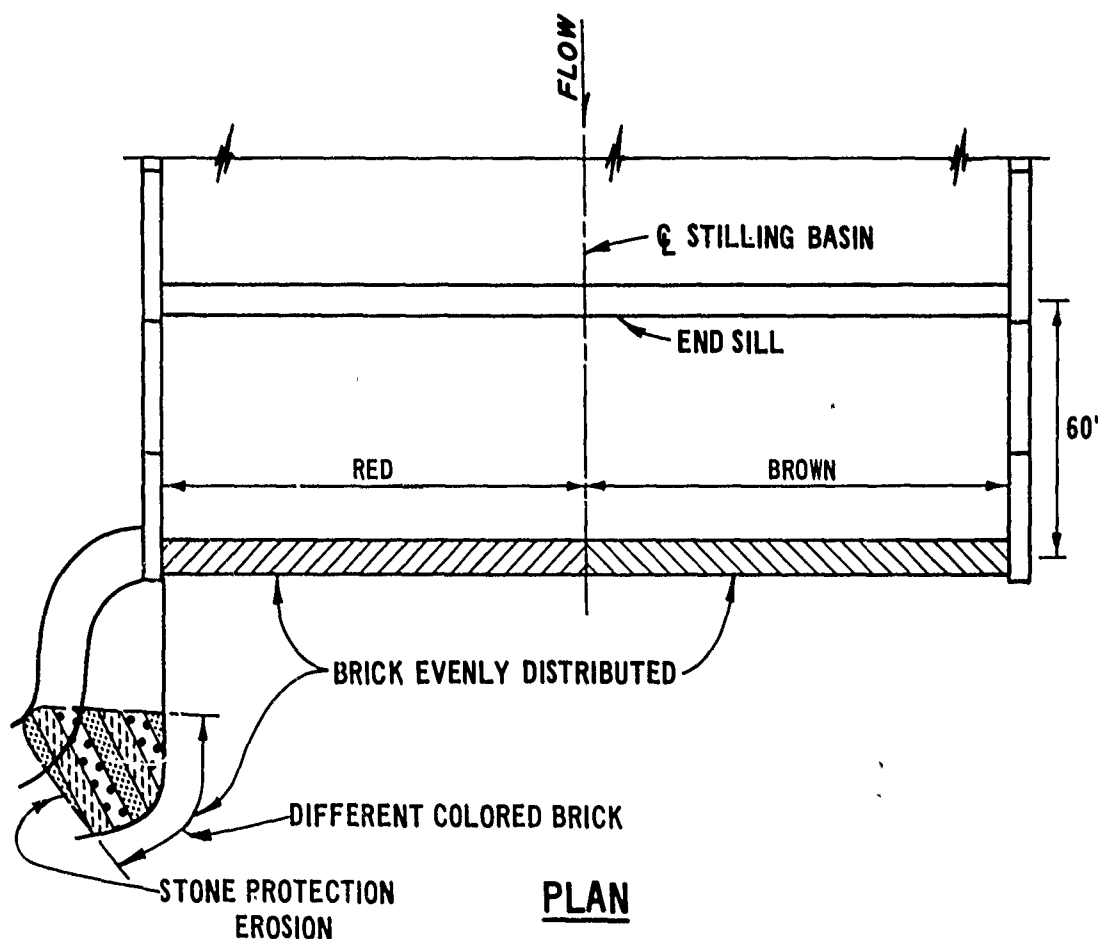
261. The initial diver inspection of the repair in November 1974 indicated minor concrete deterioration on some of the baffles and in the surrounding floor area. Two large areas of epoxy repairs at the base of the spillway were missing. An estimated 45 cu yd of debris was removed from the basin. At that time the District conducted an experiment to determine whether currents and eddies carried material back from the channel downstream of the stilling basin and over the end sill into the stilling basin. Approximately 5500 bricks of three different types were dropped from a boat into the river and were distributed downstream of the basin (Figure 149). Six days after the placement of the bricks, the

Figure 149. Experiment to determine source of stilling basin debris, Kinzua Dam

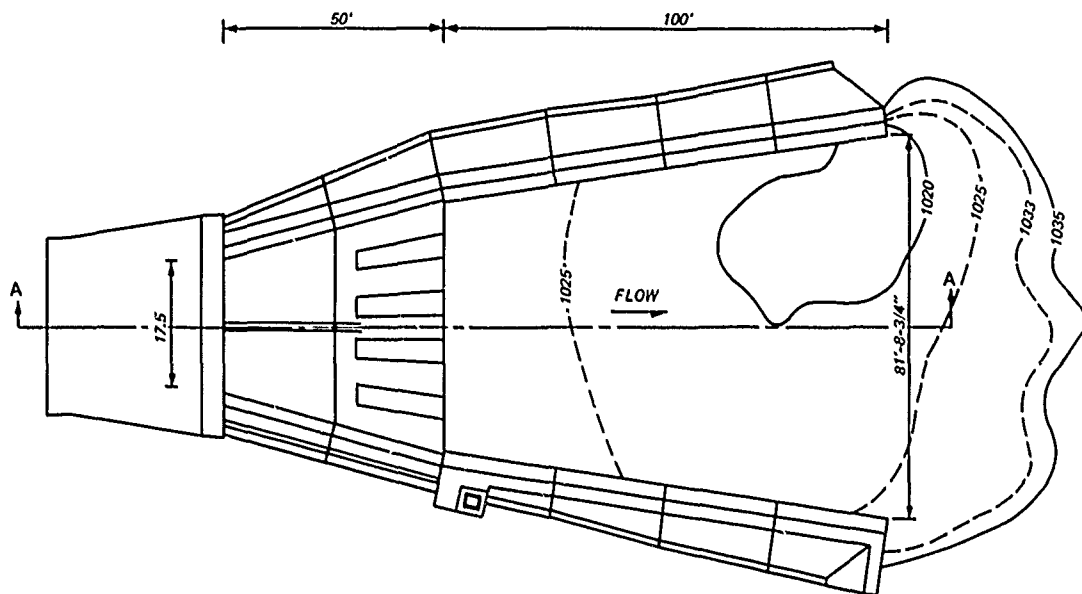
Figure 150. Stilling basin plan, Tionesta Dam

274. After nearly 30 years of service, large holes were observed in the stilling basin floor in the unpaved rock area. The eroded area varied from only about a foot (el 1034.0), a short distance downstream of the paving, to as much as 16 ft at the downstream end of the stilling basin (Figure 150). The erosion was a little more severe on the left side of the basin than on the right with undercutting of the sidewalls. A decision was made in March 1968 to restore the stilling basin floor as nearly as practicable to its original condition.

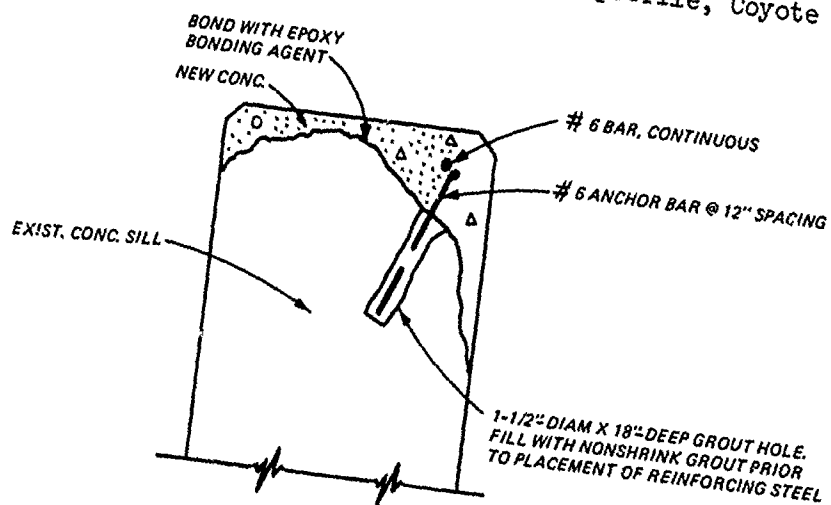
295. In 1969, erosion of the end sill was repaired using concrete proportioned for 4000 psi compressive strength at 28 days. The new concrete was bonded and anchored to the existing sill (Figure 159). In an effort to prevent future erosion and loss of downstream riprap, an additional row of baffles was constructed (Figure 158). A 2-in. saw cut was made in the basin slab to outline the new baffles and the inscribed concrete was chipped out to a depth of 2 in. Anchor bars were embedded in the existing concrete with a nonshrink grout and the baffles were reinforced (Figure 160). During the repair work the contractor diverted a flow of 300 cfs around the site and kept the basin dry by pumping.

Figure 159. End sill repair, Coyote Dam

NOTE: NEW REINFORCING STEEL PLACED ONLY IN AREAS WHERE EXISTING STEEL IS EXPOSED BY EROSION.

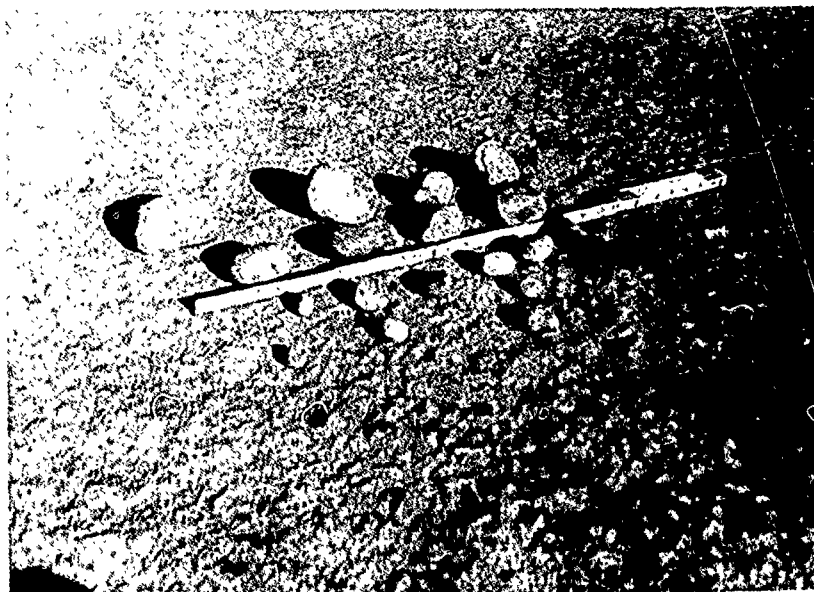
319. Inspections of the unwatered stilling basin in October and November 1952 revealed deposits of sand, gravel, timber, and miscellaneous scrap steel. The largest deposit (Figure 169) was in monolith 21, and most of the pieces of rock and steel deposited in the basin were rounded by abrasion (Figure 170). Areas of eroded concrete and exposed reinforcing steel were present on or immediately downstream from the first elliptical step below 12 of the 16 conduit outlets and on or immediately downstream from the second step below 6 of the conduit outlets. Locations of the eroded areas are shown in Figure 171 and typical examples are shown in Figures 172 and 173.

Figure 170. Typical abraded aggregate from debris deposits, Bull Shoals Dam (from Little Rock District 1953)

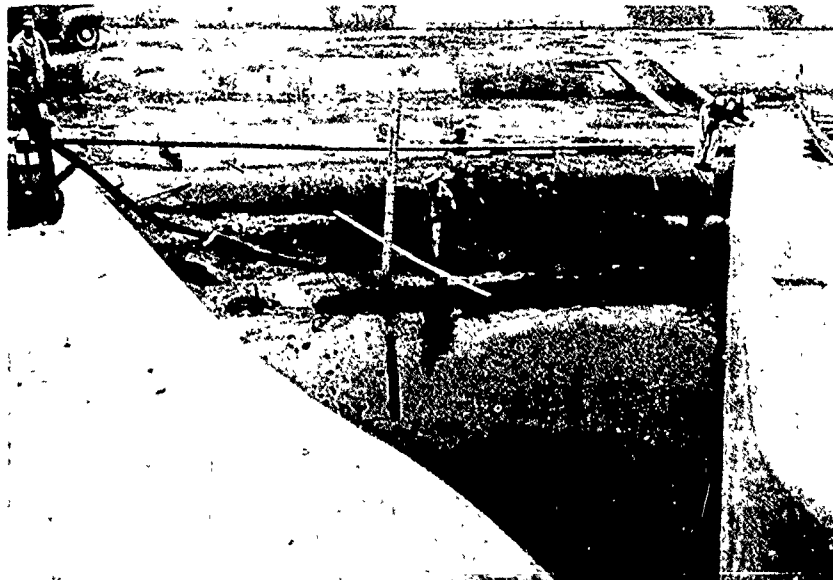
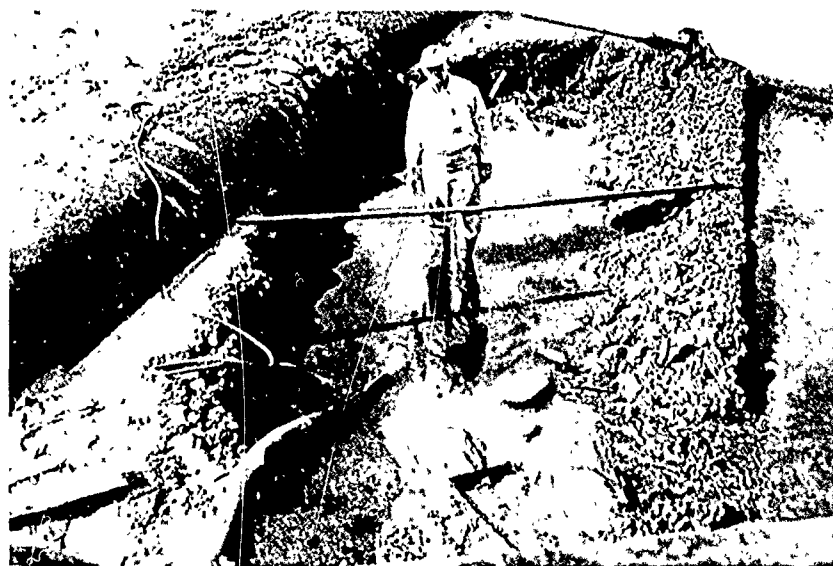
321. Damage occurred downstream from only those conduits which had been operated during this period, but only a very general relationship was found between the eroded volume and the flow data (Figure 174). The erosion on the first steps ranged in depth to a maximum of about 3.5 ft. The exposed reinforcing steel appeared to have failed because of bending fatigue as there were no "necks" characteristic of tension failures. The downstream ends of many longitudinal reinforcing bars appeared to have been "peeled" out of the 3-in. concrete cover, leaving rough grooves about 2 in. wide, 4 in. deep, and 1 ft long. On the top

Figure 172. Erosion of first step and face of second step downstream from monolith 22, Bull Shoals Dam (from Little Rock District 1953)

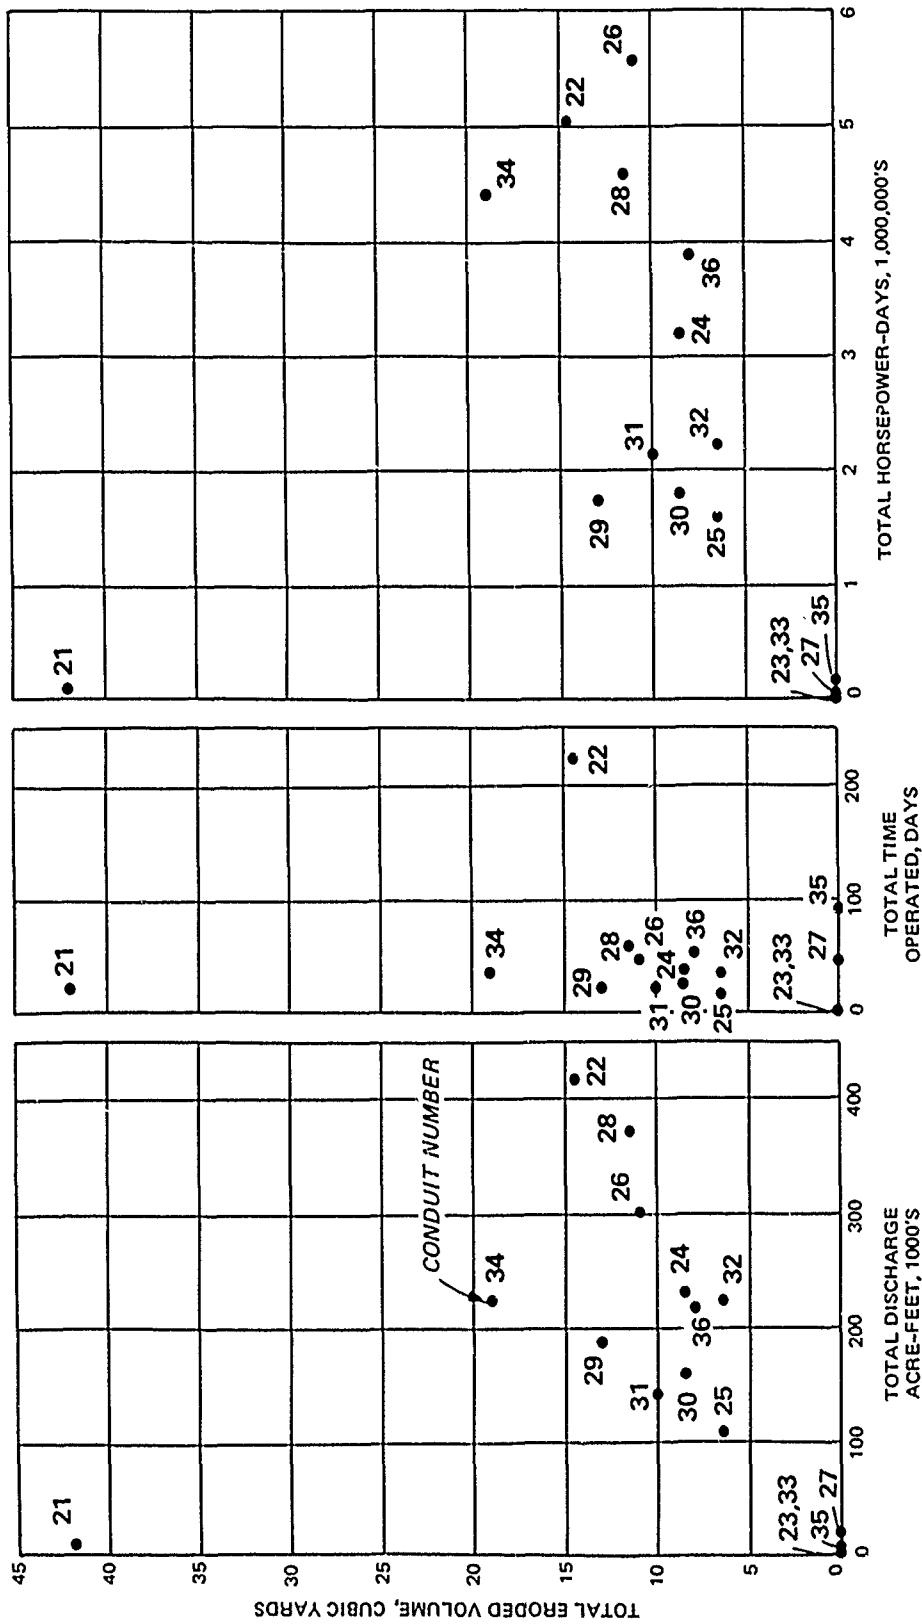
Figure 174. Relationships between erosion and flow, Bull Shoals Dam  
(from Little Rock District 1953)

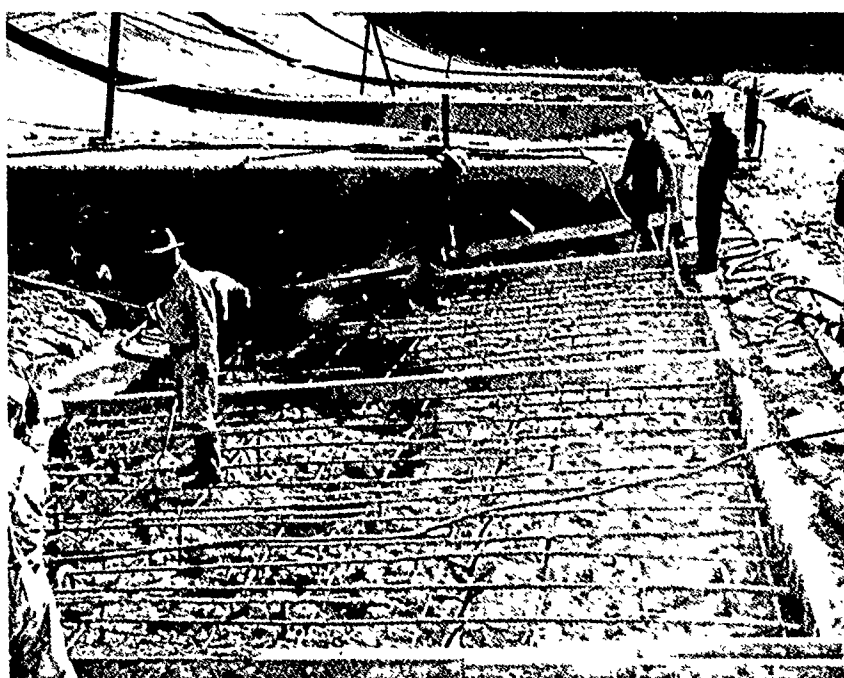
a. Concrete removal

b. Immediately prior to placing new concrete

Figure 177. Repair operations downstream of monolith 26,  
Bull Shoals Dam (from Little Rock District 1953)

323. Concrete in the stepped areas was broken with paving breakers and was excavated by hand. Anchors were grouted into holes drilled on 4-ft centers each way and reinforcing mats were welded to the anchors (Figures 176 and 177).

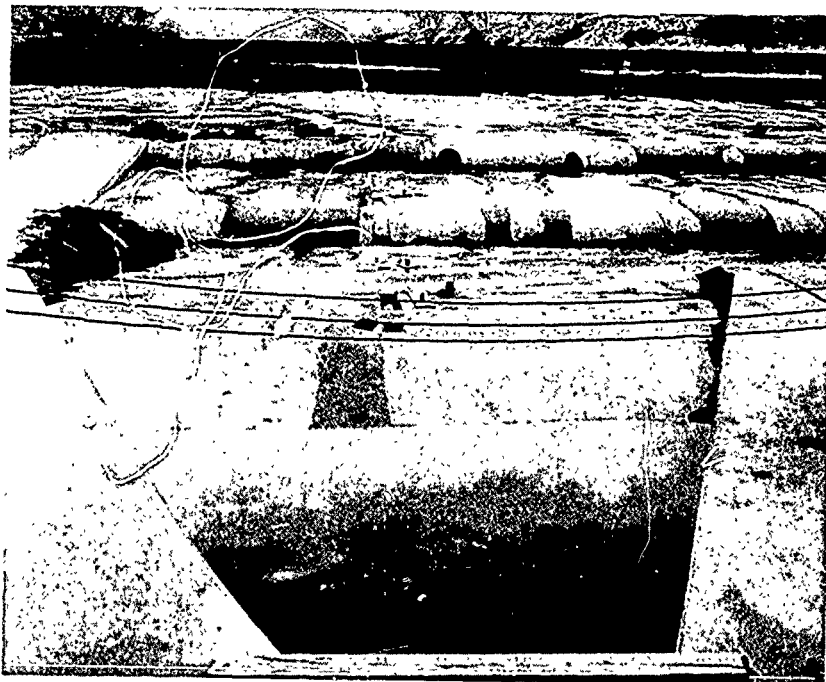
a. Slab replacement of first and second steps, monolith 22

b. Slab replacement of four steps downstream from monolith 21

Figure 178. Completed repairs, Bull Shoals Dam  
(from Little Rock District 1953)

No air entraining admixture was used. Average compressive strengths at 7 and 28 days were 3630 and 5820 psi, respectively. All concrete surfaces were given a hard troweled finish. Typical completed repairs are shown in Figure 178. The repairs were made by contract from November 1952 to January 1953 at a cost of \$67,689, excluding dewatering, which was accomplished by hired labor at a cost of \$11,947.

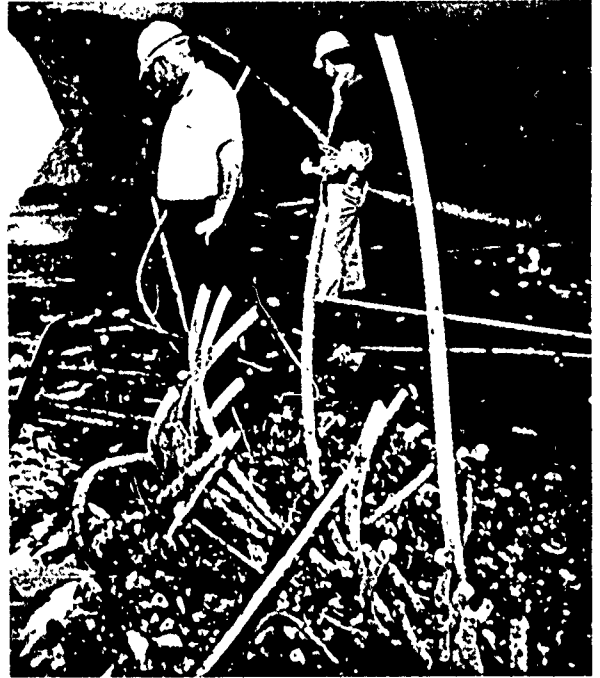
Figure 185. Right stilling basin damage, Oologah Dam

1970, revealed only minor areas of scour on the floor and three baffles with cavities deep enough to require repair. Repair were made by installing anchor bolts and filling the cavities with epoxy mortar. The second inspection of the basin in September 1975 revealed that a large amount of damage had occurred since the first inspection and presumably since the pool was raised in 1972. In the right basin, the erosion of the floor was deep enough (17-in. maximum) to expose and remove reinforcing steel from two separate layers (Figure 185). In comparison, the left basin lost very little reinforcement but most of the top layer was exposed (Figure 186). Most of the baffles had exposed reinforcing but the erosion was generally confined to about 18 in. at the base (Figure 186). It was concluded that erosion of the stilling basin concrete resulted from debris trapped in the basin.

a. Loose reinforcement removed from right basin

b. Stilling basin after removal of loose reinforcement

c. Floor of right basin. Note broken rebars

had to be removed. Other preparation necessary prior to placing the overlay included grouting No. 4 anchors into the old concrete, extending the slab weep holes (Figure 187), replacing No. 11 bars in the right basin, installing temperature reinforcement for the overlay concrete, and cleaning the old concrete surface by sandblasting.

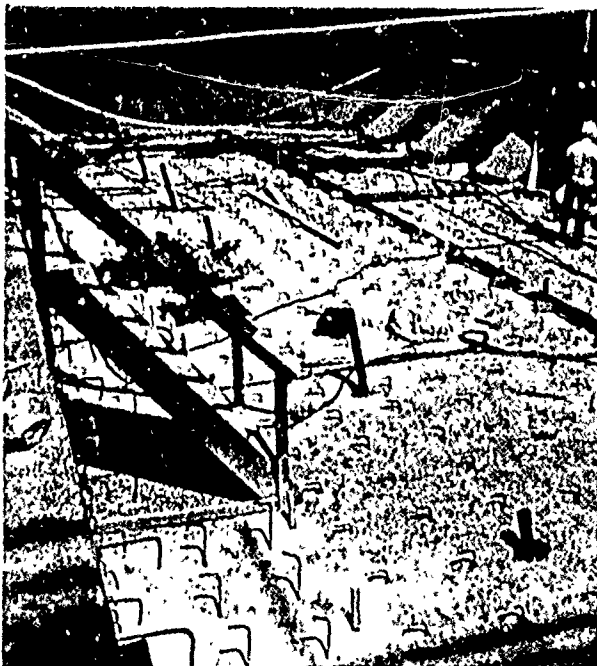
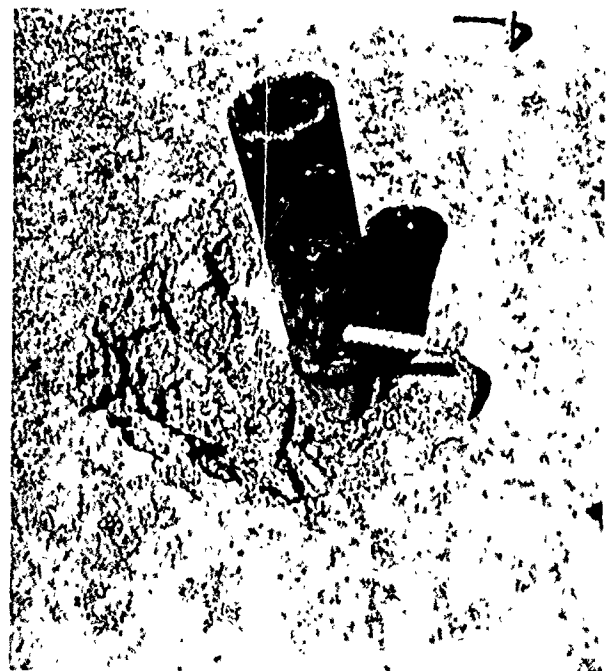
Figure 187. Stilling basin repair, Oologah Dam

a. Floor of basin during preparation for overlay. Note holes drilled to receive anchors

b. Floor of basin with anchors and drain extensions in place

c. Floor and end sill being prepared for overlay

d. Weep holes from foundation drains extended through overlay
